SCREEN DAMAGE

INSPECTION SCREEN LEFT ON TURBINE DURING START-UP WIPED BEARING

By Larry B. Jordan, Sr. Technical Advisor, RIG

Case Study

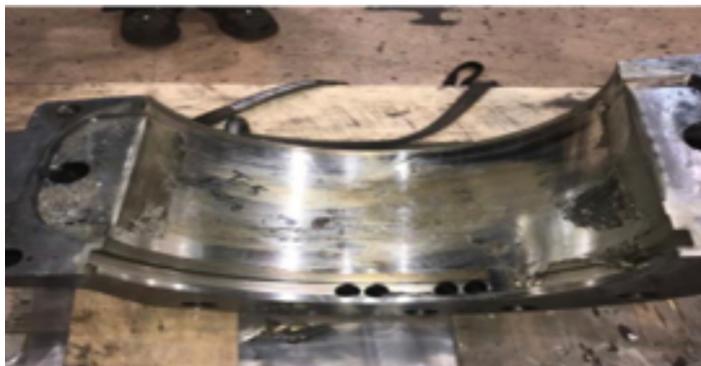
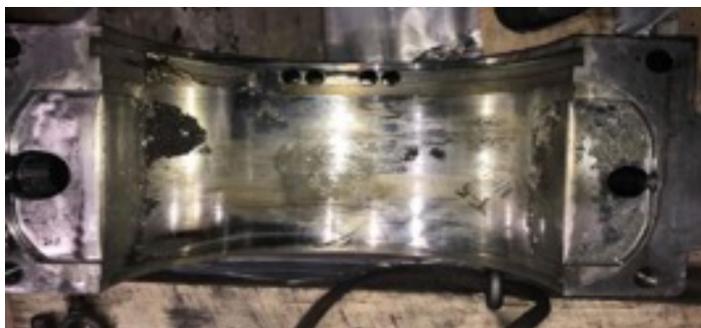
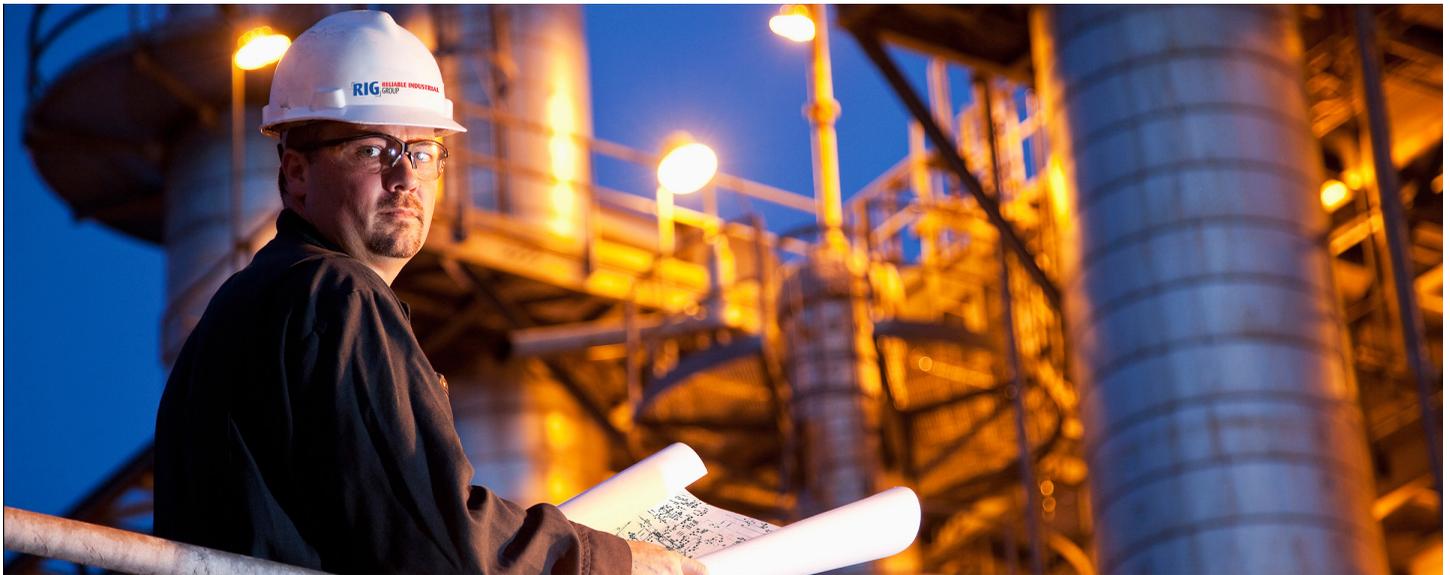
During a power generation plant start up activities the Steam Turbine tripped due to high vibration on the HP bearing. Disassembly and inspection of the bearing showed the HP T5 bearing had been wiped and a fine mesh screen installed on the orifice strainer, resulting in oil starvation to the bearing, and subsequent failure.

The fine mesh screen was installed in the T5 bearing orifice strainer during required turnaround flushing activities and was not removed prior to startup. The checklist for tracking fine mesh screens included only LP train T1-T6 and HP train T1 and T2. A final check of the T5 bearing orifice strainer was only for orientation. It was not expected that a fine mesh strainer was installed and flange slip screen fine mesh screens can be difficult to identify visually.

Damage due to loss of lubrication

The T5 bearing was shipped to vendor to be re-spun. The Turning Gear and T5 oil deflectors were shipped to vendor to be re-toothed. The H2 seal casing required replacement.
