INDIANAPOLIS, IN, GE TURBINE HVOF

Case Study

*A GE Turbine system and Main Lube Oil Tank (MLOT) needed a thorough cleaning and contaminate removal to improve bearing life and protect the turbines critical parts. A lube oil flush, side-stream filtration, mechanical pipe cleaning, and varnish removal process performed by RIG achieved an ISO particle count better than 15/14/10.*

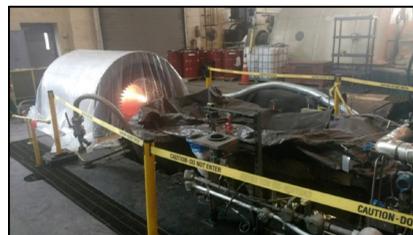
Figure 1. Jumper Setup

Equipment was offloaded and staged in designated area. The bearing jumpers were installed on the inboard and outboard side of the generator. Piping connected to the turbine inboard and outboard bearings was removed for manual mechanical cleaning. All instrumentation lines were disconnected and capped to prevent migration of contamination into those lines. The accumulator lines were isolated to prevent flow to the removed accumulator.

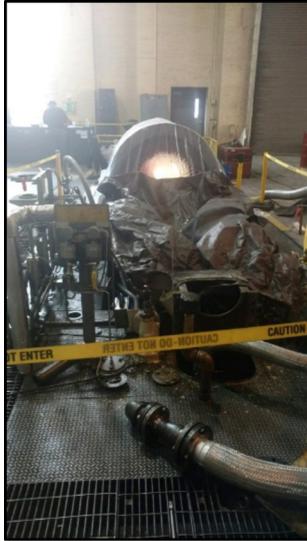
Figure 2. Suction and Discharge-Lines to Flush Skid

The reservoir was drained upon arrival and a reservoir cleaning was conducted prior to flushing. RIG's 350gpm high flow filtration skid was connected to the onboard pump discharge line inside the reservoir. To supply RIG flush unit a "stinger" was attached to the supply line and inserted into manway. Allowing RIG's skid to draw oil from the main lube oil tank (MLOT).

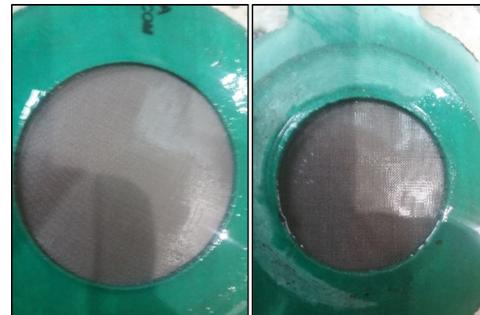
Figure 4. Final Verification Screens

At the conclusion of the course flush inspection screens were installed for a one-hour run. The initial screens revealed a large amount of contamination remained in the system. Screens were reinstalled at 24-hour intervals until the screens passed API 614 visual cleanliness standards. The final verification screens were approved by the customer at 3:45pm on 12/19/17.

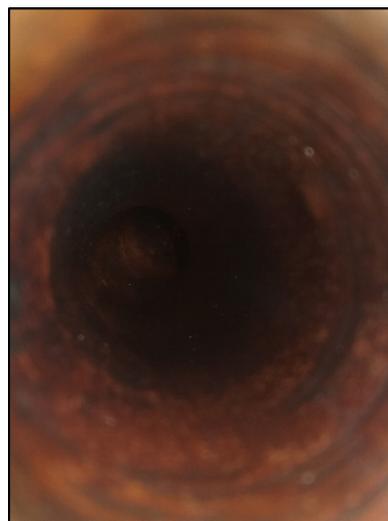
Figure 9. Copper Tubing

Many of the bearing supply lines on the lube oil system are copper in construction. The inside of the copper tubing has deteriorated and copper was evident on the rags used during the mechanical hand cleaning of the removed tubing. Bends in the tubing have created uneven surfaces that have encouraged contamination build up. In the third-party lab results elemental spectroscopy section

copper is reading 9ppm. Replacement of this tubing and carbon steel piping with stainless steel could extend bearing life.

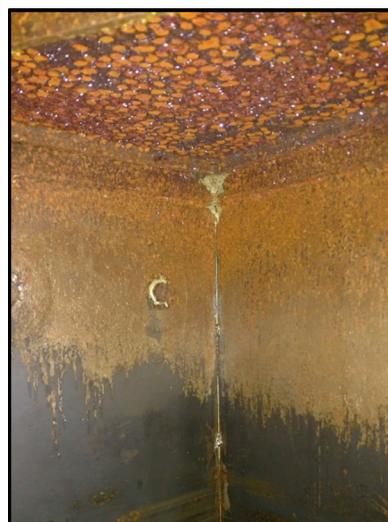
Figure 10. Evidence of Condensation in MLOT

The MLOT had evidence of condensation, a desiccant type breather will mitigate this condition. Quarterly filtration of the Lube Oil reservoir with side stream filtration will help keep system within OEM specifications.

The main lube oil tank (MLOT) has several areas that can be repaired or covered to prevent ingress of contamination. With the lack of inline filtration, it is essential to keep the MLOT as free of contamination as possible. With this, a replacement of the traditional breather with a desiccant type breather prevents ingress of both contamination and water.
