HIGH VELOCITY HOT OIL FLUSH

FOLLOWING MAJOR TURNAROUND ON WESTINGHOUSE 501AA

Case Study

RIG provided high velocity hot oil flush services on the Unit #1 Westinghouse 501AA located in West Phoenix.

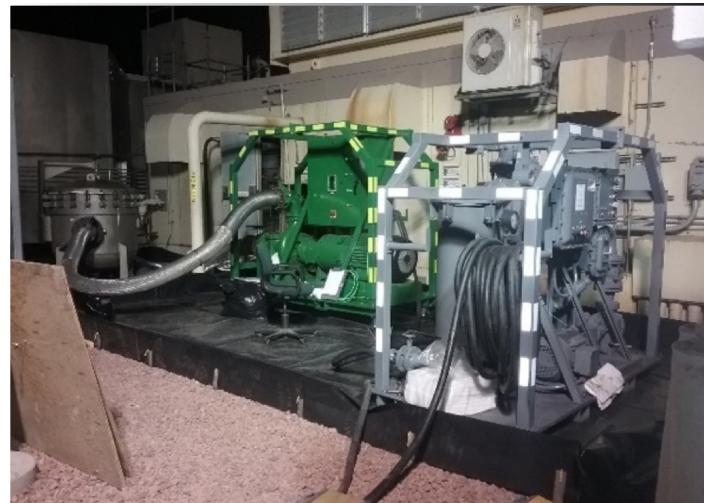
Figure 1. Lube Oil Supply Header Tie-In

Lube Oil Supply Header Tie-In

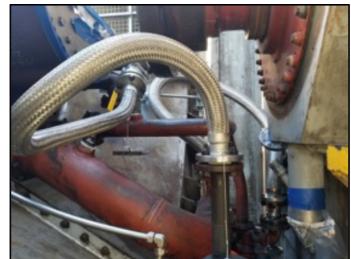
Figure 2. Jumpers

RIG equipment was staged in the designated area. Stainless Steel bearing jumpers were installed on the outboard and inboard sides of turbine, on the generator, inboard and outboard of the exciter, and the "S" clutch. All jumpers included valves allowing flow to be focused to individual bearing supply points. Prior to arrival the main lube oil reservoir was drained into a frac tank and cleaned. Once jumpers were installed and external flush equipment rigged, the lube oil reservoir was filter filled for flush.

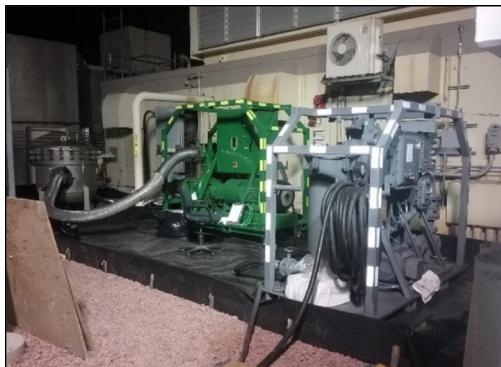
Figure 5.
External Flush
Setup

Utilizing the Variable Frequency Drive on RIG's 2000 GPM flushing skid, technicians started circulation system slowly while checking for leaks. Oil flow was increased providing a calculated turbulent flow of 32,958 Reynolds number. RIG's flushing system flowed through a 25 bag filter kettle loaded with 1um bag filters. Heat and fine filtration was provided in a "kidney loop" configuration on the main lube oil reservoir by a 150 GPM pump skid. 1um beta 1000 filter cartridges were loaded into the filter vessel. The target temperature for the flush was between 120-160 degrees Fahrenheit. Heat cycling and pneumatic vibrators were used to encourage the migration of contamination out of the system.

Once maximum flow was achieved a final leak check was performed system wide. The leak check passed and circulation was continued for a 36-hour course flush to remove the bulk of contamination.

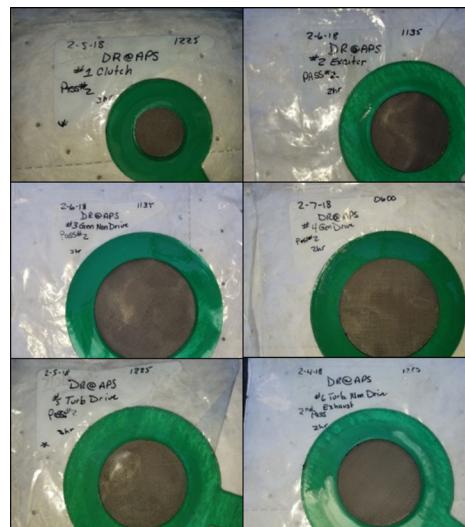
Figure 7. Final
Screen Pulls

At the conclusion of the 36 hour course flush, the flushing skid was shut down and inspection screens were installed at each bearing supply point. Flushing skid was restarted for a two-hour run to assess contamination levels in the system. The initial screens revealed a large amount of contamination remaining in the system. Screens were reinstalled at 24-hour intervals until improvement dictated final inspections. Each screen pass required two consecutive clean screens at two hour runs meeting API 614 visual cleanliness standards. The final verification screens were approved by DR/Siemens on Day 5.

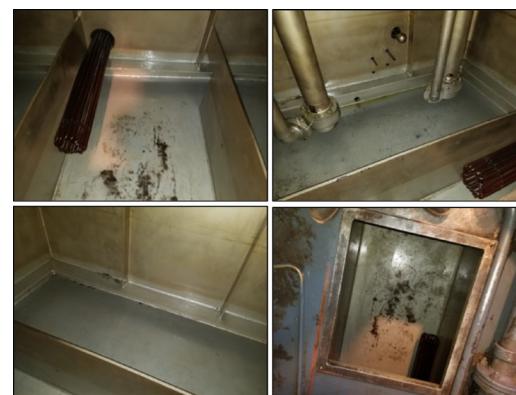
Figure 8.
Reservoir
Cleaning

After verification of system cleanliness the RIG supply, discharge lines, and jumper materials were removed. The mechanically cleaned piping was reinstalled by DR/Siemens millwrights. Foreign material exclusion practices were used on all connections open to the atmosphere. The main lube oil reservoir was cleaned. Filling of the main lube oil reservoir was performed using 1um beta 1000 filtration and verified clean using the on-site laser particle counter. Filters, waste oil, and oily rags were properly disposed of on site. RIG equipment was removed from site and housekeeping was conducted in the work area.
