PETROLEUM REFINERY

CENTRIFUGAL GAS COMPRESSOR VARNISH REMOVAL & HVOF

Case Study

SYNOPSIS

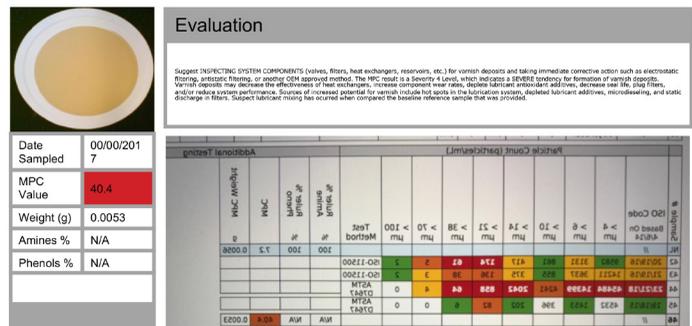
Figure 1. Evaluation

In addition to a high level of wear metal contamination the refinery's centrifugal compressors lubricant was showing MPC values >40 which put it in a critical level for varnish potential.

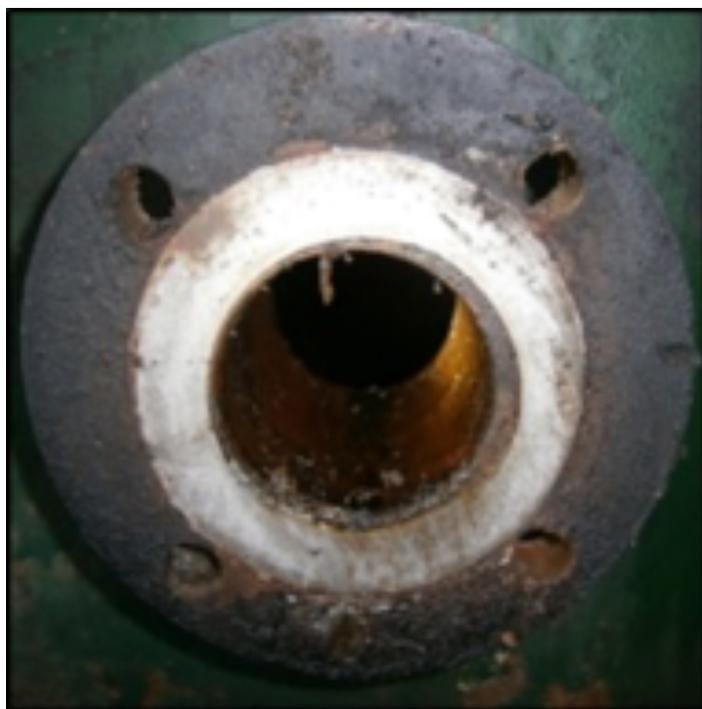
3" 150# Suction on The Reservoir Prior to Flushing

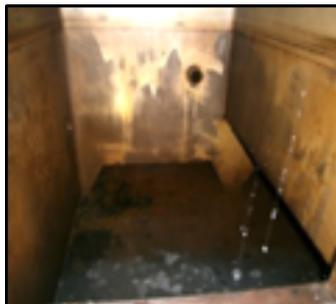
Supply to the flushing skid was pulled from the lube oil reservoir. Figures 2, 3, & 4 show various items from the lube oil system prior to flushing and cleaning.

Figure 2. Interior of the Oil Reservoir Prior to Cleaning and Flushing

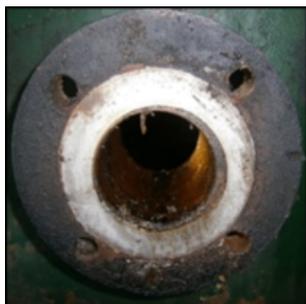
Figure 3. 3"150# Suction On the Reservoir Prior to Flushing

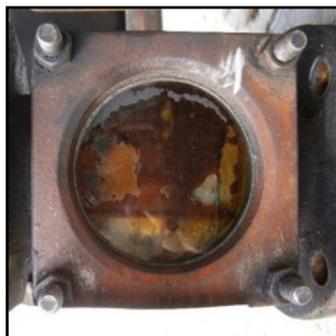
Figure 4. Sight Glass Removed for Hand Cleaning

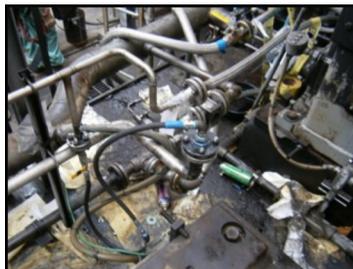
The system spools were removed in preparation of installation of the RIG supplied flushing jumpers. Additionally RIG personnel made connections from the flushing equipment to the compressor lube oil system.

Figure 5. Gearbox and Compressor Jumpers

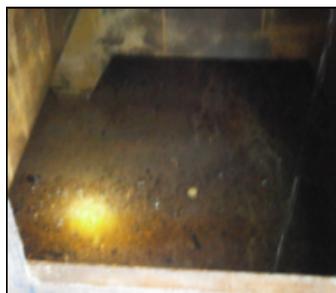
The door on the oil reservoir was removed to gain access to the interior for cleaning. Large amounts of debris ranging from paint chips to varnish and sludge were found in the reservoir. Confined space entry was

Figure 6. Debris in the Oil Reservoir After the Varnish Mitigation Flush

not allowed at this facility, so the reservoir was cleaned from the outside with squeegees and shop vacuums. The final reservoir cleanliness was inspected and approved by the customer representative.

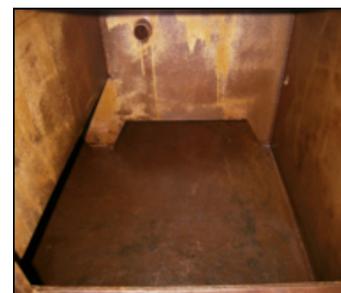
Figure 7. Oil Reservoir After Cleaning Post Varnish Mitigation Flush

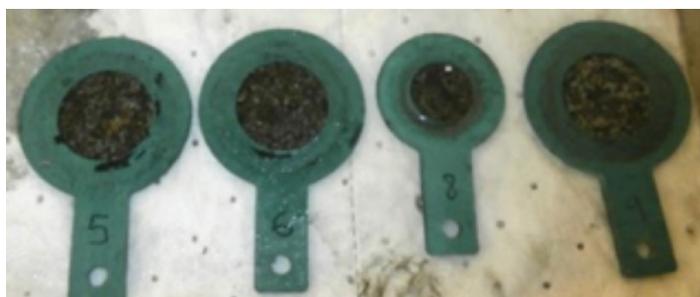
After the reservoir was inspected and covers reinstated, the system was filled with virgin oil. The purge and particulate flush was started. This stage removed any residual system cleaner from the oil system and was used for inspections for particulate contamination. Initial inspection screens became plugged with debris after an hour of flushing. (See Figure 8)

Figure 8. Initial Inspection Screens Check After 1-Hour Flushing

A course flush was executed without inspection screens installed for 12 hours. After 12 hours, a subsequent one-hour screening run showed improvement. The flush continued with RIG technicians alternating flow through the oil coolers and filter housings every hour.

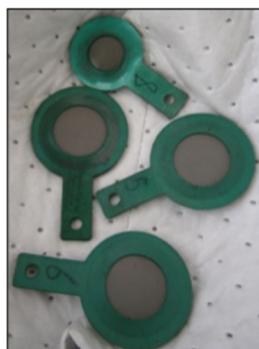
Inspection screen runs were performed until a one-hour run produced clean screens. A confirmation screen one-hour run was performed to confirm the pipe cleanliness. Final inspection screens are shown in Figure 8. The purge oil was field tested for particle count and returned an ISO code of 15/14/10. The final fill oil was also tested and returned an ISO code particle count of 16/14/11. The test results for the field particle counter are shown in Figures 10 & 11.

Figure 9. Final Inspection Screen Check

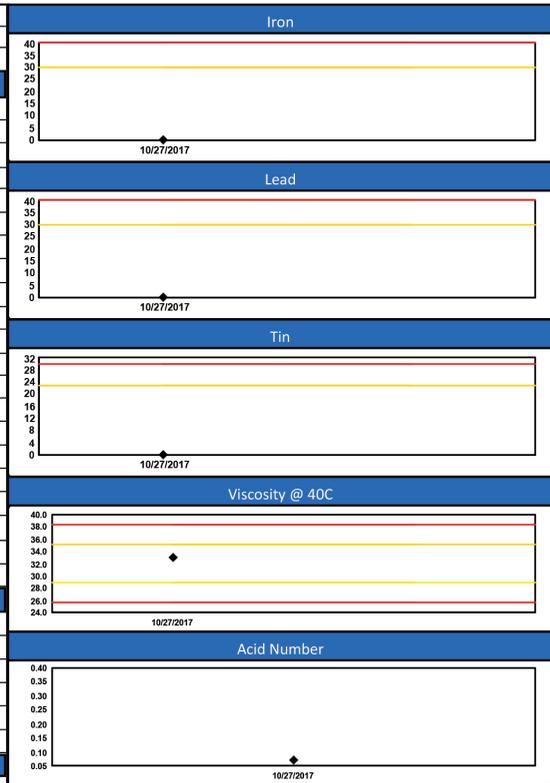
Appendix I: Purge Oil – Post Flush Analysis Results

Machine Condition **NORMAL**
 Lubricant Condition **NORMAL**
 Machine Name: Citgo Lemont - #13 GB Post Rinse

PROBLEMS No problems found with current sample.

COMMENTS The results for this sample indicate normal conditions. Please continue scheduled sampling.
