RIG'S HVOF FLUSHING EXPERTISE AND SPECIALIZED EQUIPMENT ACHIEVE SUCCESS FOR CUSTOMER STRUGGLING TO CLEAN AN ETHYLENE COMPRESSOR

Case Study

SYNOPSIS

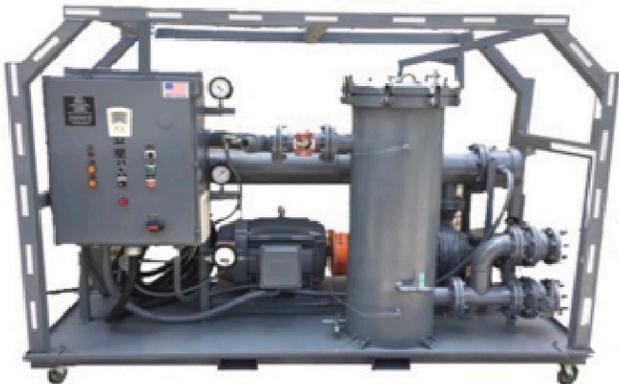
RIG deployed custom flushing equipment.

RIG deployed custom flushing equipment to the plant in Sarnia, Ontario for the flush designed to achieve higher velocity during cleaning and incorporate efficient oil filtration. An experienced RIG technician was also on-site for the entire flush to provide both the day and night shift crews with technical expertise. The equipment used included:

- Centrifugal Pump capable of 3-700 GPM via Variable Frequency Drive Controls.
- (5) Microglass Beta 1000 Filtration
- 72 KW Heaters
- Stainless Steel Pressure Tested temporary hoses
- On-Site Particle Counter
