CRITICAL VARNISH DEPOSITS REMOVED WITH ZERO DOWNTIME FROM SOLAR TITAN 130 TURBINE

By Larry B. Jordan, Sr. Technical Advisor, RIG

Case Study

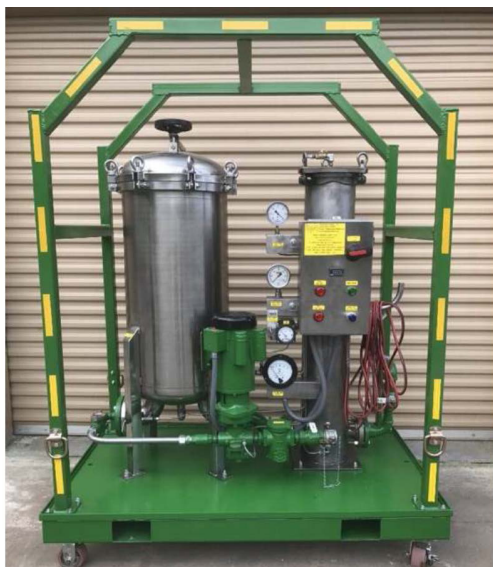
RIG's Varnish Absorption System. RIG deployed filtration equipment and a certified plant maintenance technician to perform the in-line filtration.

RIG deployed filtration equipment and a certified plant maintenance technician to perform the in-line filtration. The full service package included:

- Installation of RIG's varnish absorption system (VAS) to run side stream filtration
- Training of onsite personnel to monitor and operate the VAS so inline filtration can be run as needed by plant staff to achieve and maintain target ISO cleanliness levels.
- Instructions and sampling bottles with shipping labels for oil analysis to independently verify ISO cleanliness levels.

The varnish absorption method used by RIG is a resin based polar attracting technology. Our 10 GPM VAS system is designed for reservoirs up to 5,000 gallons. The VAS equipment has the following specifications:

- A dual varnish absorptive housing – 20" diameter x 40" long which leads into a
- A 640-series pleated micro-glass filter housing

- Two varnish removal elements with 5,000 gallons of turbine oil, which are designed to lower varnish MPC value from MPC=42 to <25MPC
- Two additional elements may be required to bring down to <15 MPC.
- In applications where water is greater than 500PPM, a vacuum oil purifier can be added on to lower dissolved water to less than 100PPM

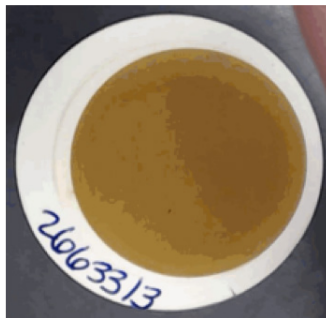
Figure 1. Original Lab Analysis Membrane Patch Colorimetry MPC 62

A joint municipal plant's turbine generator showed critical varnish deposits during a turbine lubricant analysis. To remove the varnish, Solar and the municipal plant contracted the Reliable Industrial Group (RIG) team to remove the varnish deposits.

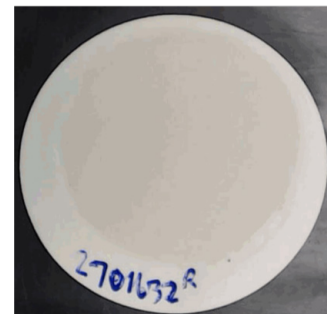
Figure 2. After - MPC Value: 10

RIG was able to perform the varnish mitigation services with the system online. The critical varnish deposits were removed, and the particle count was lowered from a 16/15/11 to a 15/14/10 during the same timeframe utilizing the Varnish Adsorption Skid. This was achieved without interrupting plant operations and prevented any unscheduled downtime due to varnish contamination while also extending the life of the lube oil.

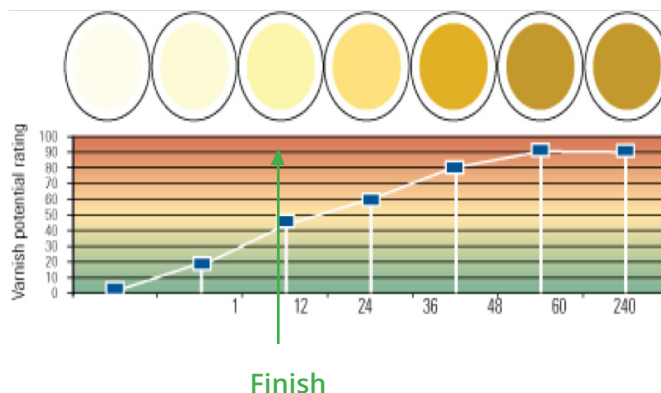
Figure 3. Varnish Potential Rating
