SCREEN DAMAGE

INSPECTION SCREEN LEFT ON TURBINE DURING START-UP WIPED BEARING

By Larry B. Jordan, Sr. Technical Advisor, RIG

Case Study

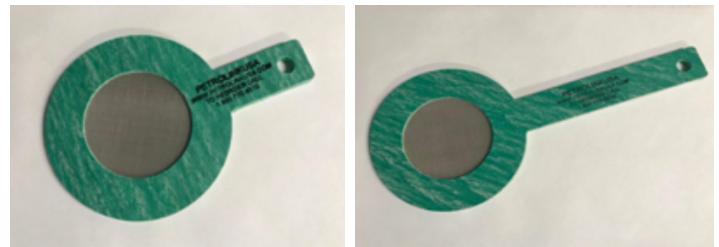
Figure 1. PLI-Screens

RIG PLI-SCREENS ARE EASILY IDENTIFIED WITH GREEN GARLOCK MATERIAL AND HANDLES THAT EXTEND BEYOND THE FLANGES.

Inclusion of a reinstatement checklist and verification signatures utilized in tracking removal of oil flushing inspection screens in every flushing activity will prevent these incidents from taking place. Concurrently, utilizing easily identifiable PLI-Screens will allow verification at a glance (See Figure 1 below). The Flush Company Lead should perform a final walk through with OEM and Site Representative when completing the High Velocity Lube Oil Flush.
