PAPER MACHINE FLUSHING

PREVENTING CONTAMINATION AND BLOCKAGE IN RETURN LINE

By Larry Jordan, Sr. Technical Advisor, RIG

Whitepaper

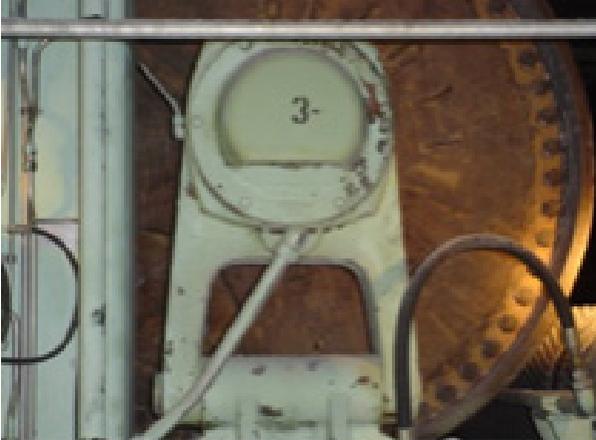
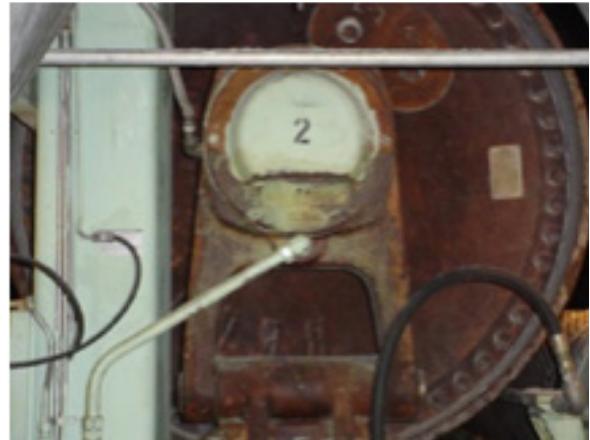
The Paper Machine Dryer Bearings below are beside each other on the same machine. Bearing housing on the right has more paint missing and rust.

- High Temperature?
- Exposure to Water?

Figure 2a. Left: Paper Machine Dryer Bearings

Figure 2b. Right: Paper Machine Dryer Bearings

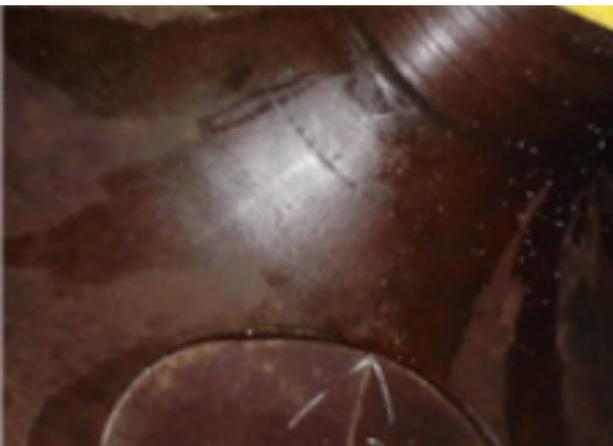
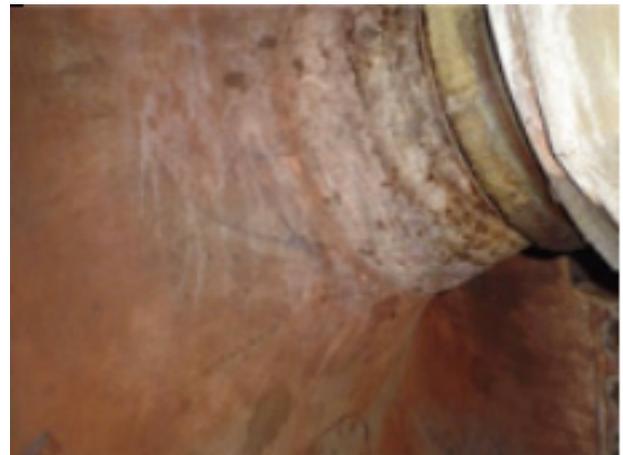
The Dryer Bearings below are beside each other on the same machine. Bearing housing on the left is wet with oil indicating a labyrinth seal leak.

- Damaged Seal
- Contamination build up blocking return line
- Contamination in Bearing Housing

Figure 3a. Left: Dryer Bearings wet with oil

Figure 3b. Right: Dryer Bearings

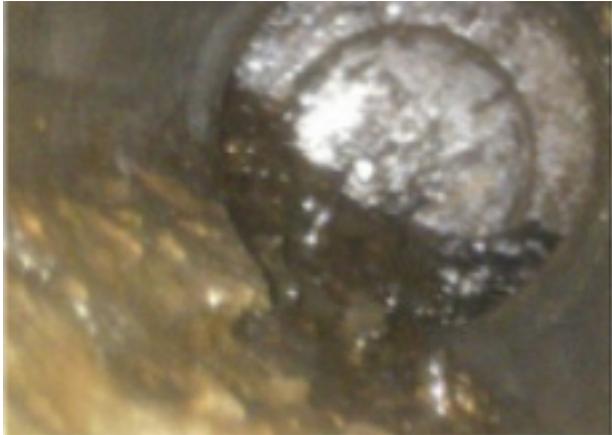
The Paper Machine Dryer Bearing drain channel below are on the same machine. Wear metals, Oil oxidation, paper are just some of the material that can cause blockage in these areas.

Figure 4a. Before

Figure 4b. After

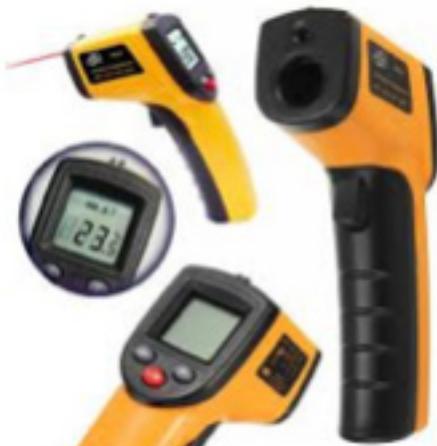
Monitor Bearing Temperatures. Use a Temp Gun to take readings across all the bearings to find "Hot Spots".

Figure 5. Temp Heat Gun

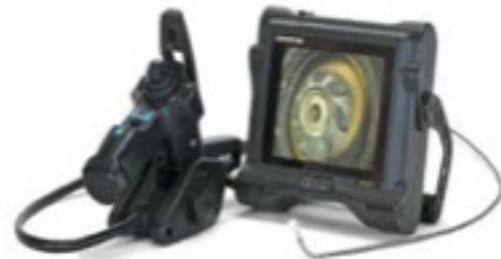
Use a bore-scope to go inside bearing and visually inspect condition of drain.

Figure 6. Bore-Scope

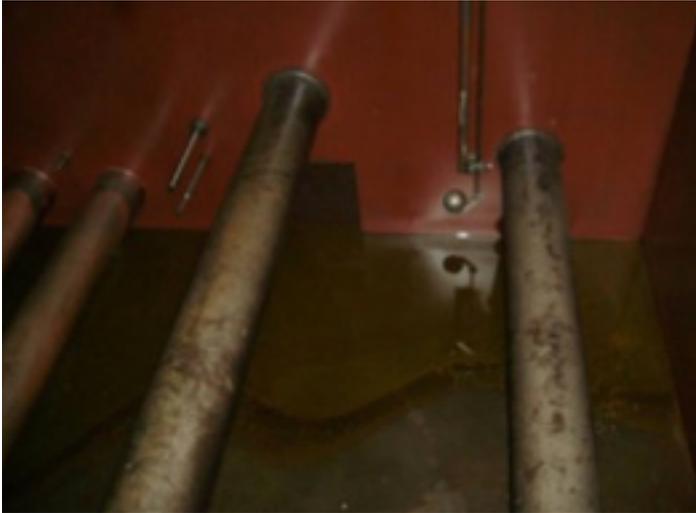
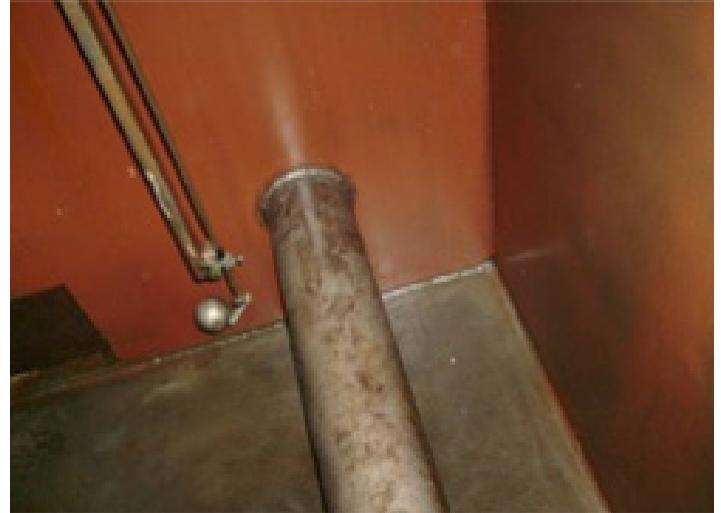
When flushing contamination out of the bearings and headers it is important to include cleaning the reservoir and recondition the lubricant. This can include filtration for particulate and dehydration for water removal.

Figure 8a. Before Cleaning

Figure 8b. After Cleaning

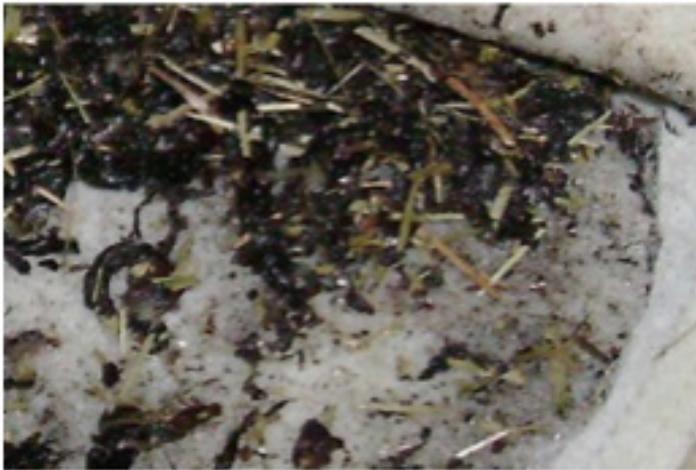
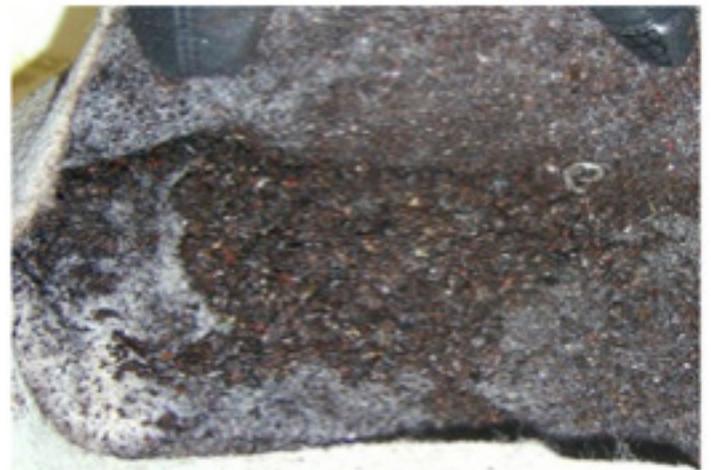
Figure 9a. Examples of Contamination removed from flush and reservoir cleaning

Figure 9b. Examples of Contamination removed from flush and reservoir cleaning
