GLOBAL TIRE MANUFACTURER MANAGED RELIABILITY PROGRAM

OIL ANALYSIS AND SIDE STREAM FILTRATION

Case Study

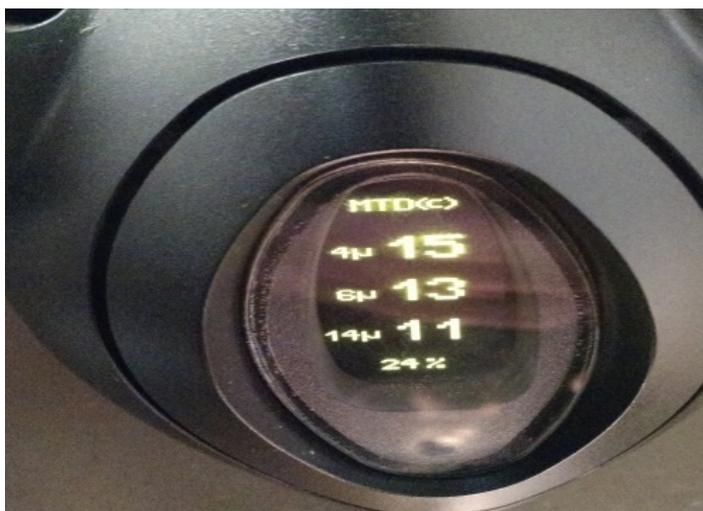
An inline laser particle counter provided real-time oil analysis

emulsified and dissolved water. It was then filtered to remove particulates in order to exceed the target ISO code of 17-15-11. An inline laser particle counter and a moisture reader verified the oil health and ISO cleanliness level as the it was pumped into the clean oil holding tanks for reuse. The holding tank was spot checked every month to ensure fluid cleanliness from a 3rd party laboratory.

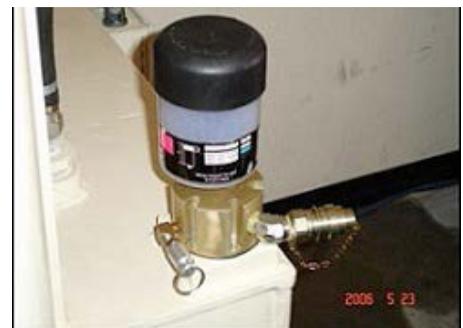
Figure 1. BSF kit installed on a hydraulic oil reservoir

Each reservoir was outfitted with a RIG BSF (Breath/Sampler/Filler) to prevent moisture accumulation while allowing the system to breath as well as provide a consistent sample and connection point for the filter cart. The BSF kits also provided the added benefit reducing opportunities for contamination by eliminating the need to open the reservoir for sampling or filtering.

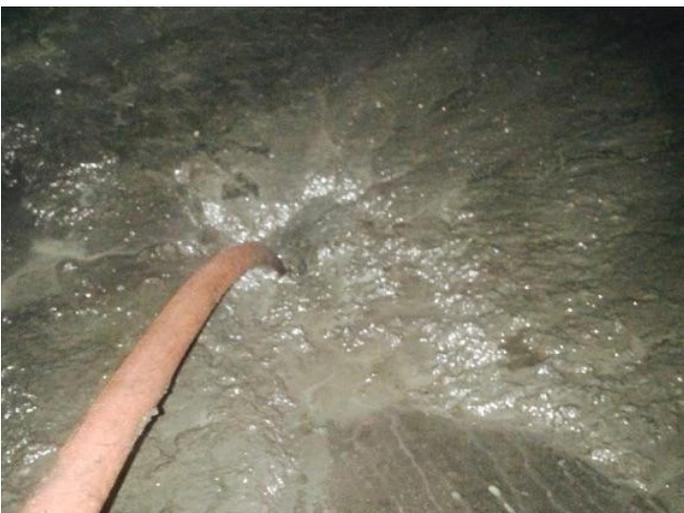
Figure 2. Oil reservoir prior to annual cleaning

The final component of the ISO cleanliness program was annual cleanings of each hydraulic reservoir. To ensure that each system was free of any dirt and debris RIG would clean each systems reservoir every year. During a shutdown period RIG's confined space certified personnel would drain the reservoir, clean the reservoir, inspect/replace suction strainer, replace all filter, and inspect/replace reservoir access gasket. By cleaning the reservoirs every year we were able to ensure that any of the build up on the tank walls and bottom of the tank were not transferred into the hydraulic system.

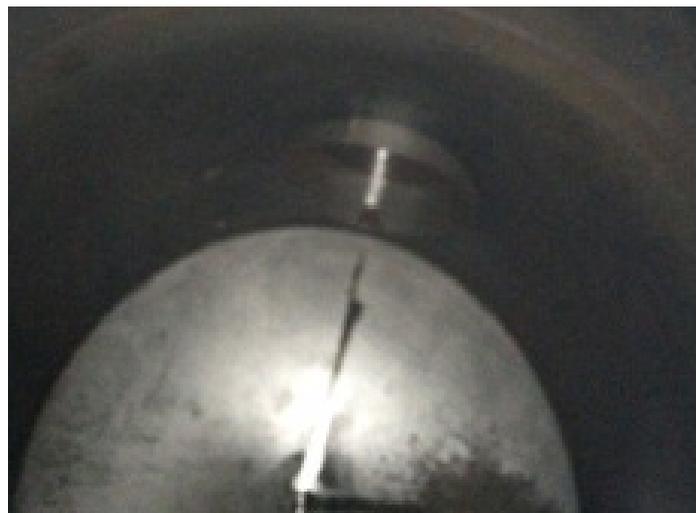
Figure 3. Clean oil reservoir after annual cleaning
