# GLOBAL PLASTIC INJECTION MOLDING MANUFACTURER

## MANAGED RELIABILITY PROGRAM OIL ANALYSIS AND SIDE STREAM FILTRATION

Case Study

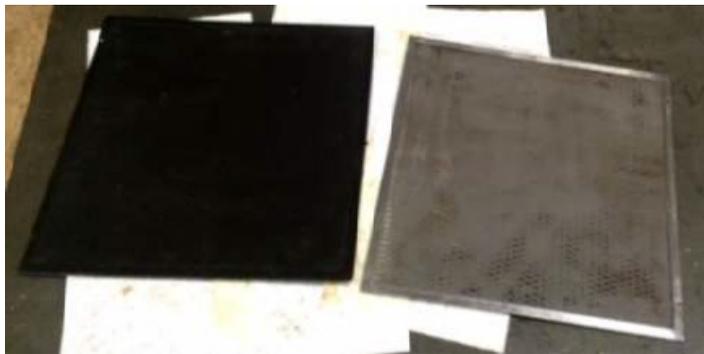
Figure 6. Screen Baffles Before and After

The final component of the ISO cleanliness program was annual cleanings of each hydraulic reservoir. To ensure that each system was free of any dirt and debris RIG would clean each systems reservoir every year. During a shutdown period RIG's confined space certified personnel would drain the reservoir, clean the reservoir, inspect/replace suction strainer, replace all filter, and inspect/replace reservoir access gasket. By cleaning the reservoirs every year we were able to ensure that any of the build up on the tank walls and bottom of the tank were not transferred into the hydraulic system.
